**Flood Control Project Maintenance
Levee Inspections**

Maintenance Issue Types Only, Levee Inspection Report By Mile - Fall 2019

Reclamation District No. 2058 Pescadero

Waterway	Bank	Unit Miles	Inspection Start/End	Inspector
Unit No. 01 Paradise Cut	Left	6.58	10/21/2019 10/21/2019	Alberto De Leon

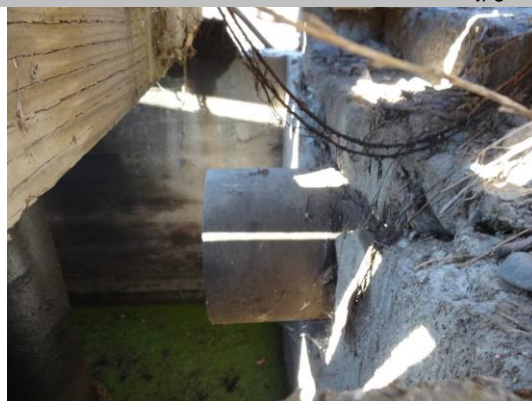
Photo 1 of 1 : UCIP_FA_2019_53531_45168.jpg

Comment Code					
Inspector Comment					
DS_ID:22704 FS_ID:53531 EP_NO: N/A Repair Type: No Action Needed Crossing Status: Found UCIP Comments: 12/07/2018 Need updated photos to show proper 12-inch pipe abandonment. If crossing was abandoned properly crossing will need to be removed from the LMA responsibility list. Also recommend updating photos for dsid 22700 (16-inch pipe) authorized under the same permit. (O. Magana - DWR UCIP) FIELD_STRUCT_DESC: *ABANDONED* 12-inch drainage discharge pipe of an unknown material through the levee, 18 feet below the crown. Pump on the landside (LS). Flap gate on the waterside (WS). (To abandon the existing 12-inch pipe with concrete and install a new 16-inch pipe authorized under Permit No. 5055, 1965 - Stanley Electric Motor Company). 12-inch pipe grouted in place. [Additional Reference(s): DWR Levee Log, 2005. USACE San Joaquin O&M Manual 10, March 1964, (HLM 0.72)]. FS Date: 5/12/2015

LS view: an abandoned pipe found in concrete sump.

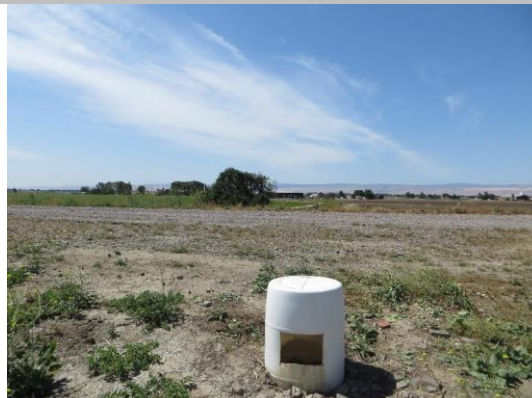
Photo 1 of 3 : UCIP_FA_2019_45865_74323.jpg

Siphon breaker on WS shoulder inside protective riser.

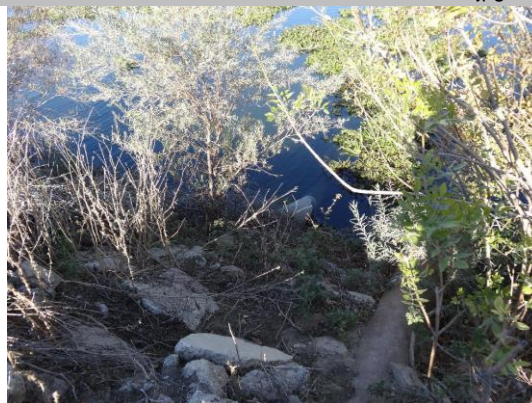
Photo 2 of 3 : UCIP_FA_2019_45865_74324.jpg

Pipe just visible at WS toe at center of photograph.

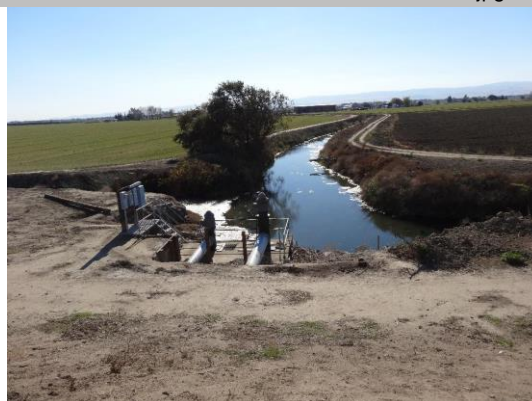
Photo 3 of 3 : UCIP_FA_2019_45865_74325.jpg

Pump on concrete pad at LS toe.

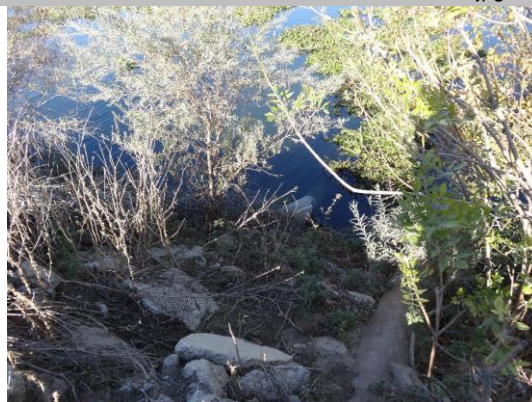
Photo 1 of 3 : UCIP_FA_2019_51699_45192.jpg

LM Start	2.12	Rating **	M	Issue No.	980
LM End	2.12	Issue Type +	Ma	Location *	
Category	Supplemental			GPS Latitude/Longitude	
				Start	End
Item	DRAFT DWR UCIP LMA Responsibility			37.803886 °	37.803886 °
				-121.386271 °	-121.386271 °
DWR ID	22706				
Comment Code					
Inspector Comment					
DS_ID:22706					
FS_ID:51699					
EP_NO: N/A					
Repair Type: Non-Urgent					
Crossing Status: Found					
UCIP Comments: Leaky and damaged siphon breaker on waterside shoulder..					
FIELD_STRUCT_DESC: 16-inch steel drainage discharge pipe through the levee, 8 feet below the crown. Pump on a concrete sump in a drainage ditch on the landside (LS) toe. Siphon breaker on the waterside (WS) shoulder. [Additional Reference(s): USACE San Joaquin O&M Manual 10, March 1964, (HLM 2.14), 12-inch pipe referenced].					
FS Date: 5/13/2015

WS view: exposed steel pipe (right) on channel bank.

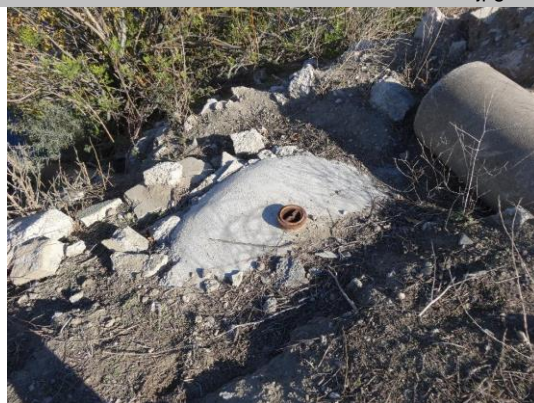
Photo 2 of 3 : UCIP_FA_2019_51699_45191.jpg

WS view: siphon breaker on concrete pad on levee slope.

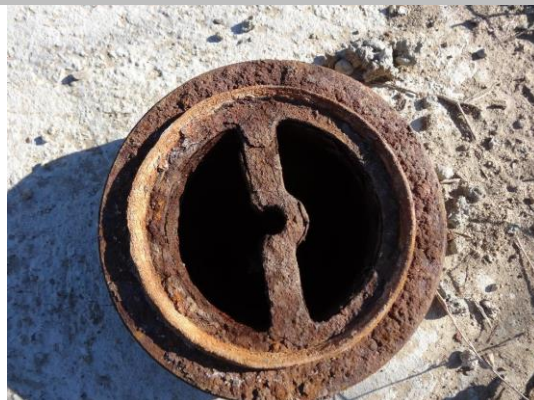
Photo 3 of 3 : UCIP_FA_2019_51699_45190.jpg

WS view: Upper part of the siphon breaker missing.

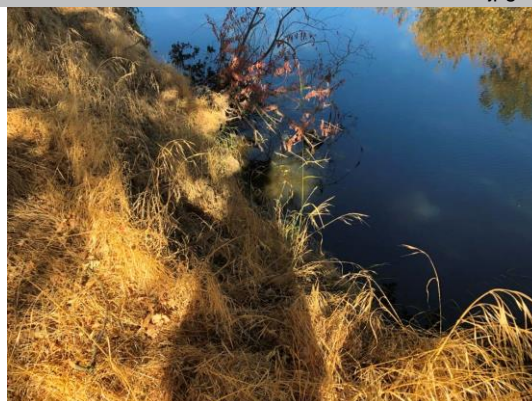
Photo 1 of 3 : SJR2019_RD2058U01RM3.97_1.jpg

Site ID: RD2058U01RM3.97
 09/25/2019: No significant change observed.
 10/10/2017: No significant change observed.
 07/20/2016: No significant change observed.
 08/04/2015: No significant change observed.
 08/26/2014: No significant change observed.
 08/28/2013: No significant change observed.
 07/26/2012: The site has been visited, and no significant change has been observed.
 09/02/2011: This site was not visited due to the time limit.
 09/22/2010: No significant change observed. Minor pocket erosions are lined at the lower bank. Two large Oak and Willow trees are on mid-slope and bench. The remaining bench was re-measured and found to be approximately 10 feet. There was no indication of active erosion on site during the site visit.
 08/05/2010: Recommended for annual assessment and monitoring of the site during flood events, per CLRO.
 07/23/2009: No major change observed since last visit; site is a 200-ft. long near-vertical berm erosion; recommend annual assessment and monitoring of the erosion site, per CLRO CES Evaluation 2008 Report; Site # is the same site previously reported as RM4.0, LM4.51; previously rated "U".

Direct view of the pocket erosion site.

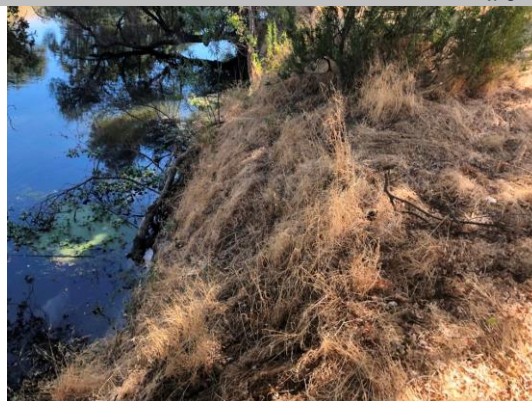
Photo 2 of 3 : SJR2019_RD2058U01RM3.97_2.jpg

Direct view of the erosion near a tree.

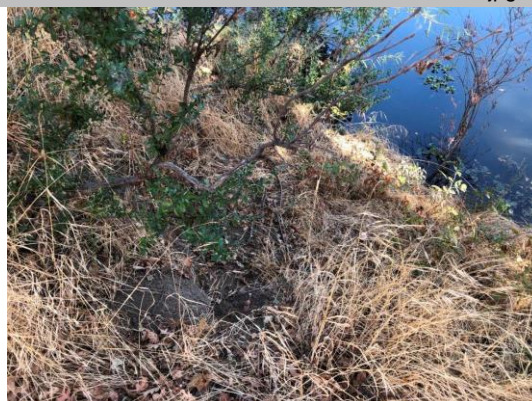
Photo 3 of 3 : SJR2019_RD2058U01RM3.97_4.jpg

Comment Code						
Inspector Comment						
Site ID: RD2058U01RM3.97						
09/25/2019: No significant change observed.						
10/10/2017: No significant change observed.						
07/20/2016: No significant change observed.						
08/04/2015: No significant change observed.						
08/26/2014: No significant change observed.						
08/28/2013: No significant change observed.						
07/26/2012: The site has been visited, and no significant change has been observed.						
09/02/2011: This site was not visited due to the time limit.						
09/22/2010: No significant change observed. Minor pocket erosions are lined at the lower bank. Two large Oak and Willow trees are on mid-slope and bench. The remaining bench was re-measured and found to be approximately 10 feet. There was no indication of active erosion on site during the site visit.						
08/05/2010: Recommended for annual assessment and monitoring of the site during flood events, per CLRO.

07/23/2009: No major change observed since last visit; site is a 200-ft. long near-vertical berm erosion; recommend annual assessment and monitoring of the erosion site, per CLRO CES Evaluation 2008 Report; Site # is the same site previously reported as RM4.0,LM4.51; previously rated "U".						
09/10/2008: Two large trees (2-3' DBH) with partial roots exposed.						
2007: Visited site 03/13/2007.

Close-up view of the erosion.

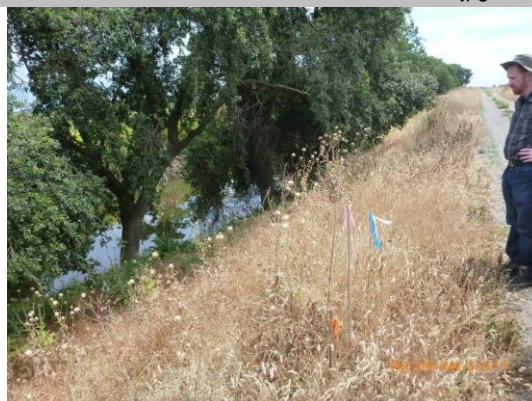
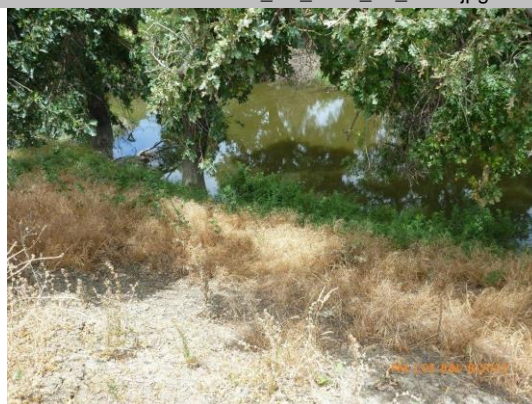
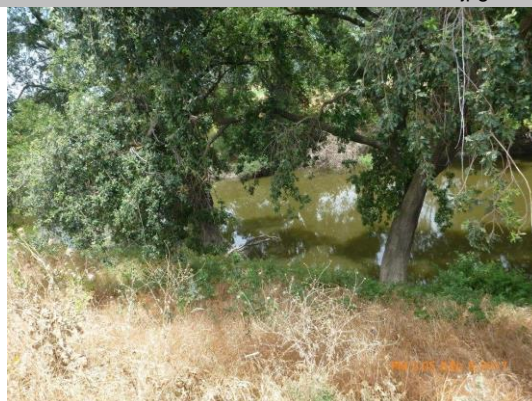
Notes: vegetation too dense to evaluate damage. Erosion on the waterside is greater than three feet tall into the levee prism as of Fall 2017 Inspection. Turned back over to Evaluators for re-assessment.

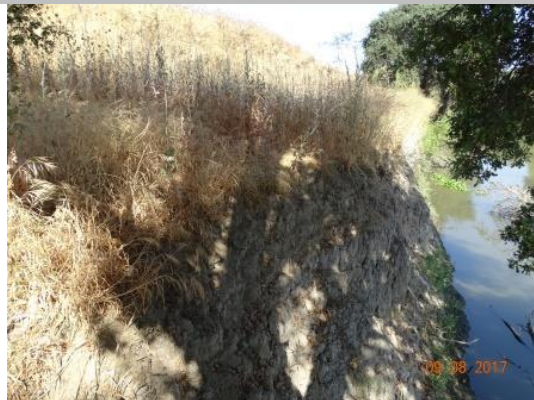
Photo 2 of 5 : FA_2019_RD2058_111_40_20190830_00023.jpg

Another downstream view of the erosion.

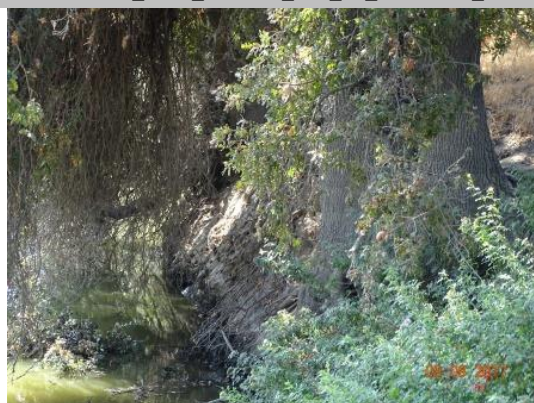
Photo 3 of 5 : FA_2019_RD2058_111_40_20190830_00024.jpg

Upstream view of the erosion site.

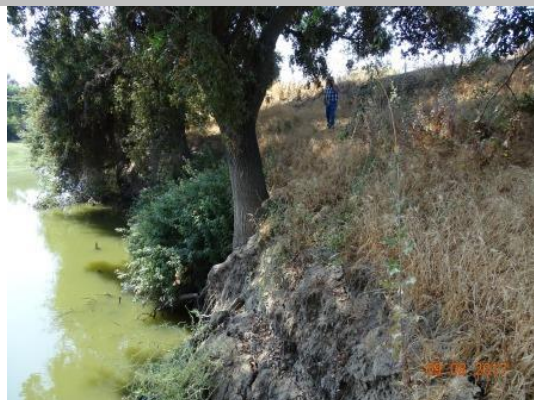
Photo 4 of 5 : FA_2019_RD2058_111_40_20190830_00025.jpg

Another upstream view of the erosion site.

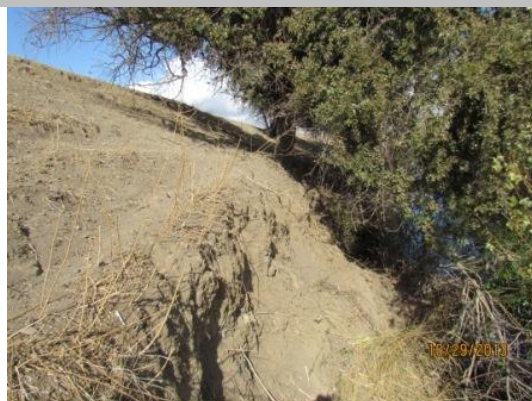
Photo 1 of 3 : FA_2019_RD2058_111_15_20190830_00007.jpg

LM Start	4.76	Rating **	A/W	Issue No.	15
LM End	4.83	Issue Type +	Ma	Location *	WS
Category	Earthen Levee			GPS Latitude/Longitude	
				Start	End
Item	Erosion / Bank Caving			37.785965°	37.785045°
				-121.350374°	-121.349936°
DWR ID	DWR_RD2058_01_f_2013_15				
Comment Code					
E1 : Note and monitor erosion site.					
Inspector Comment					
The erosion has about a 3 foot vertical cut at the waterside levee toe.

View of the erosion at the waterside levee toe.

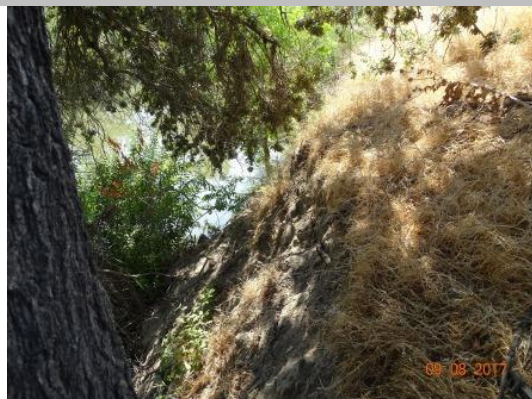
Photo 2 of 3 : FA_2019_RD2058_111_15_20190830_00008.jpg

Upstream view of the erosion.

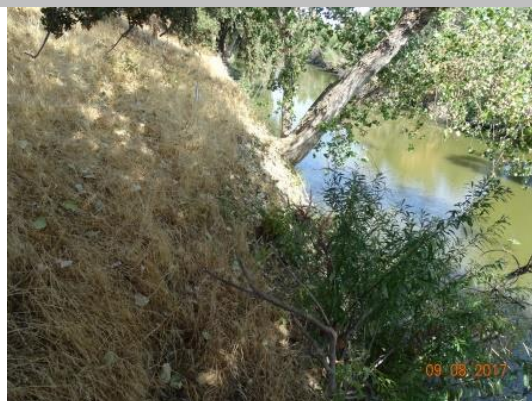
Photo 3 of 3 : FA_2019_RD2058_111_15_20190830_00009.jpg

Downstream view of the erosion site.

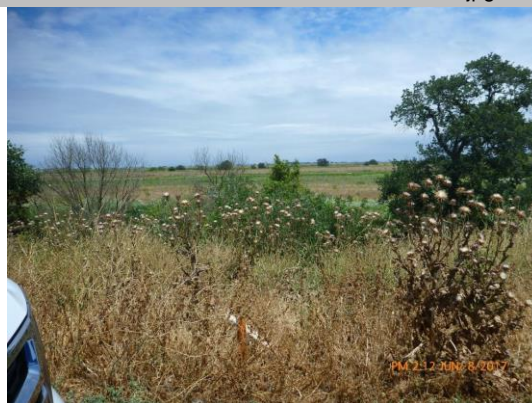
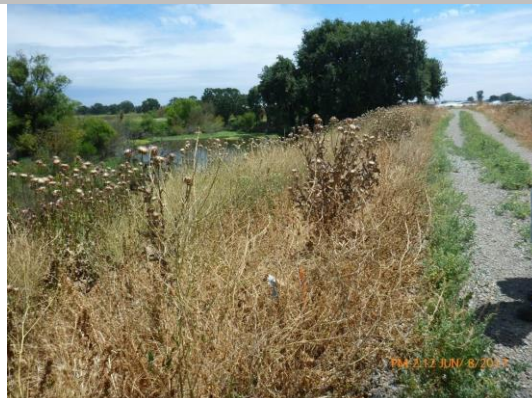
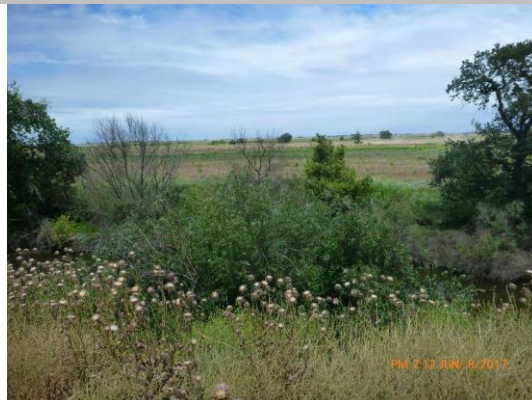
LM Start	4.77	Rating **	A/W	Issue No.	44
LM End		Issue Type +	Ma	Location *	WS
Category	Supplemental			GPS Latitude/Longitude	
				Start	End
Item	2017 Storm Damage			37.785862 °	°
				-121.350303 °	°
DWR ID	FSRP-14-25				
Comment Code					
Inspector Comment					
Levee Evaluation Comments					
Description:					
Site ID No:100					
Site Designation:FSRP-14-25					
Repair Type: Erosion					
Rating:Area of Concern					
Field Date:6/8/2017					
Notes: vegetation too dense to evaluate damage. The erosion has about a 3 foot vertical cut at the waterside levee toe as of the Fall 2017 Inspection. Turned back over to Evaluators for re-assessment.

Notes: vegetation too dense to evaluate damage. The erosion has about a 3 foot vertical cut at the waterside levee toe as of the Fall 2017 Inspection. Turned back over to Evaluators for re-assessment.

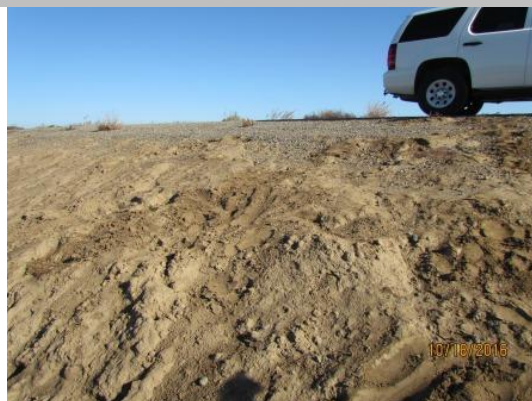
Photo 1 of 1 : FA_2019_RD2058_111_28_20190830_00013.jpg

LM Start	5.97	Rating **	M	Issue No.	28
LM End	5.97	Issue Type +	Ma	Location *	LS
Category	Earthen Levee			GPS Latitude/Longitude	
				Start	End
Item	Animal Control			37.774886°	37.774886°
				-121.335122°	-121.335122°
DWR ID	DWR_RD2058_01_s_2016_28				
Comment Code					
A3 : No rodents visible, but rodent burrows visible; need to backfill and compact or grout burrows.					
Inspector Comment

View of the rodent holes on the levee slope.
